PTPD REPORT NO. 83-R-02
AFPEA PROJECT NO. 82-P7-68

TEST AND EVALUATION OF METHOD II, GAU-8 30mm
AMMUNITION CONTAINERS

HQ AFALD/PTPD
AIR FORCE PACKAGING EVALUATION AGENCY
Wright-Patterson AFB OH 45433

August 1983

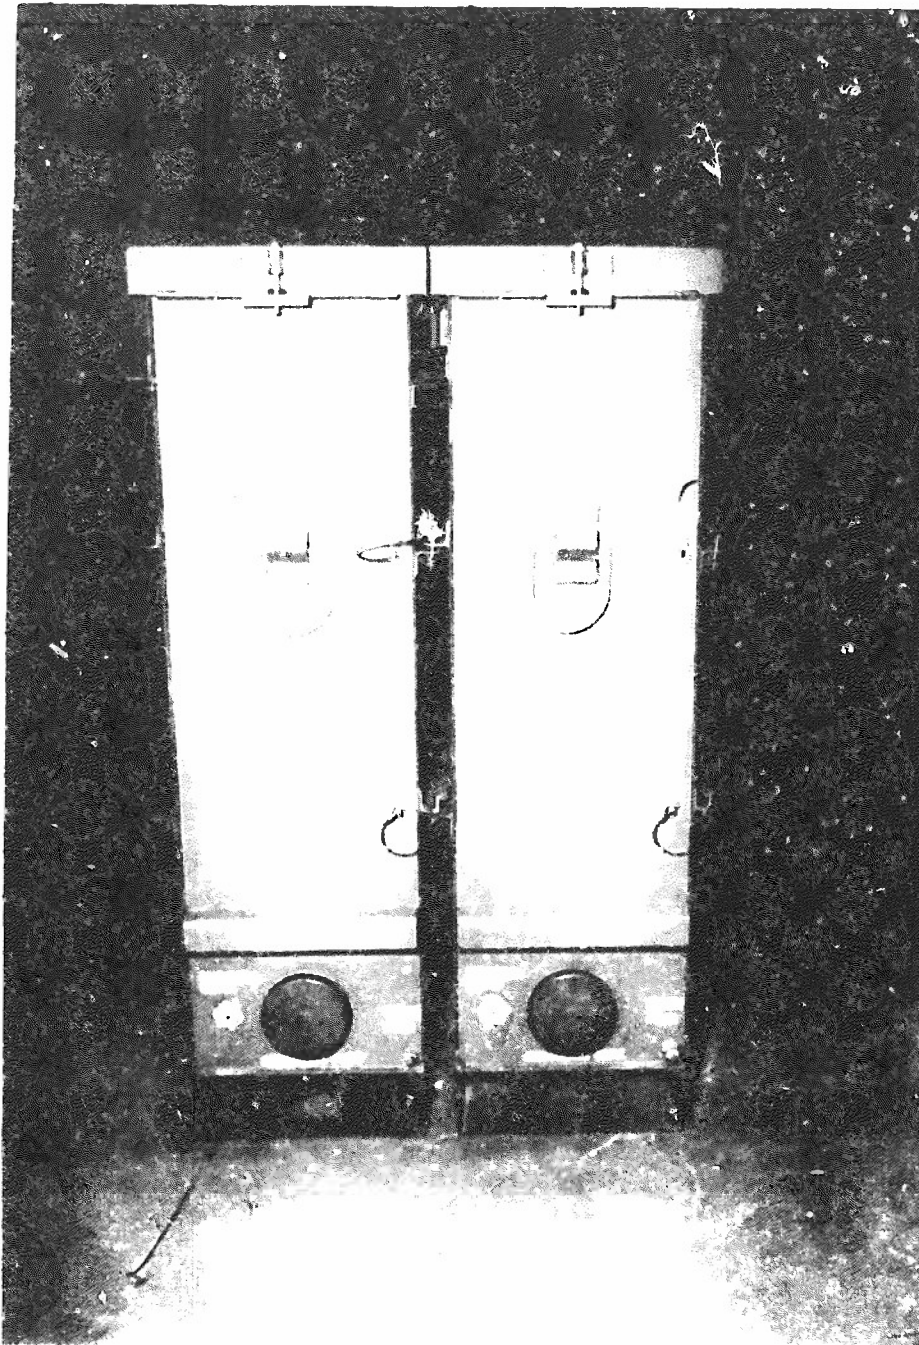
The test unit consisted of two containers pinned together at the locking angles in their normal shipping and storage configuration. Each container was fully loaded with 575 inert rounds of 30mm ammunition and belted link tube carriers (Figures 1 & 2). Each loaded container weighed 1088 pounds. The exterior dimensions of each container were 53 1/8 inches long, 14 15/16 inches wide, and 44 7/8 inches high and the total cube was 20.6 cubic feet. The test unit (both containers) weighed 2175 pounds and had exterior dimensions of 53 1/8 inches length, 28 3/4 inches width, and 44 7/8 inches height. The total cube for the unit was 39.9 cubic feet.

FIGURE 1. Container in pinned configuration forming test unit.

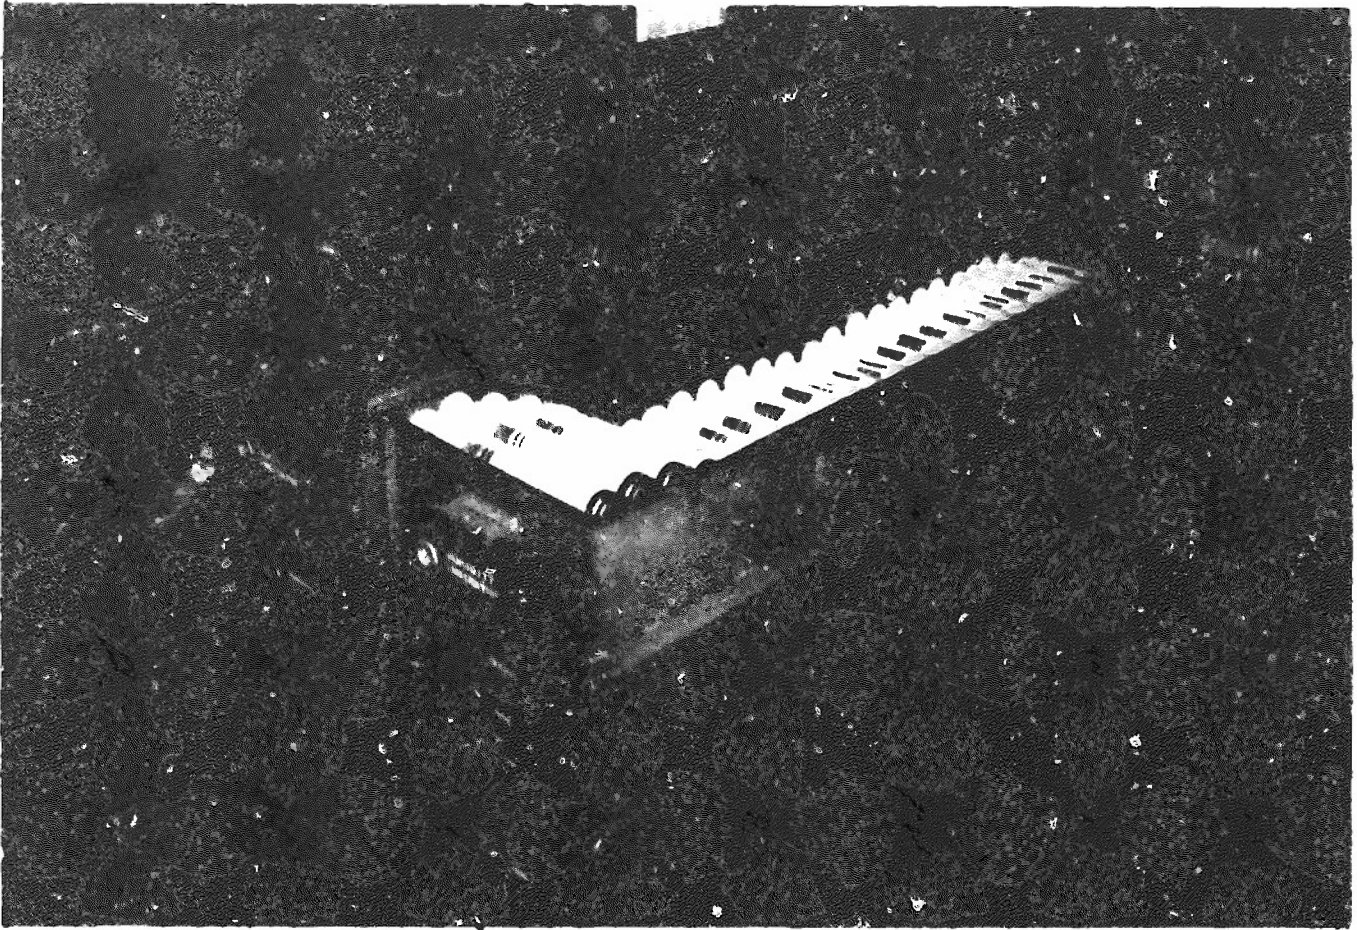
FIGURE 2. Container loaded with 30mm ammunition and link tube carriers.

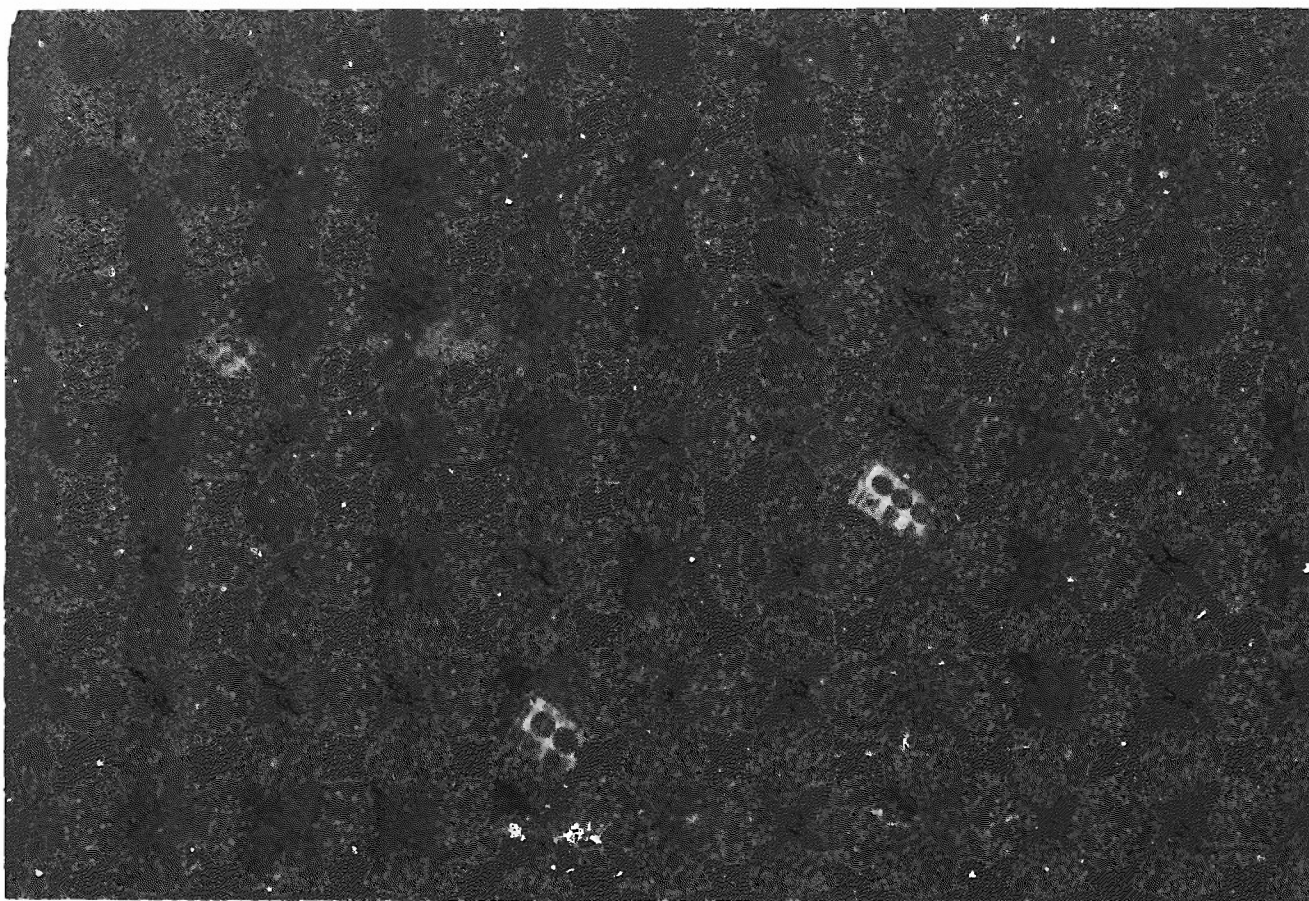
FIGURE 16. Humidity indicating devices and mild steel coupons placed in the tops of each container prior to environmental testing.
